REPAIR KIT FOR PEDAL THREAD 5/8"X24 TPI (LEFT & RIGHT)

PE-04700

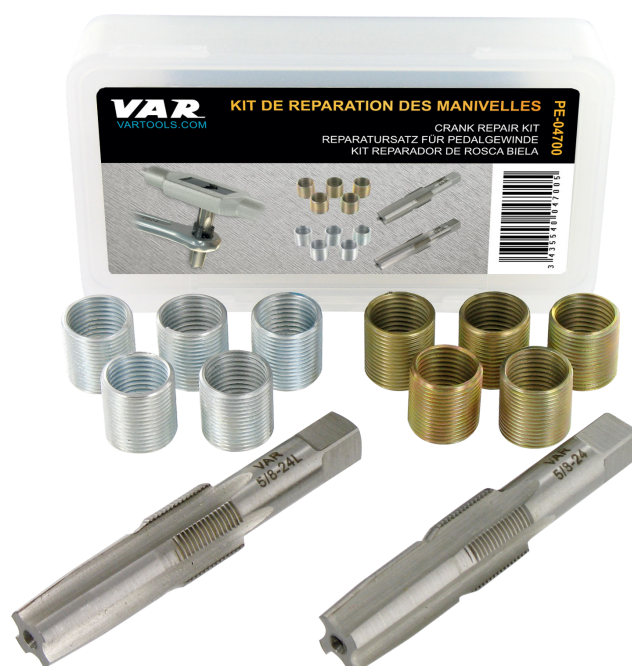
The set contains :

- 1 set of 2 reaming taps (5/8" x 24 tpi and 5/8" x 24 tpi L)
- 5 threaded inserts for right crank arm (gold)
- 5 threaded inserts for left crank arm (grey or black)
- Comes in a compartmented box
